INDOOR AIR QUALITY ASSESSMENT

**Westford Town Hall
55 Main Street
Westford, Massachusetts**

Prepared by:
Massachusetts Department of Public Health
Center for Environmental Health
Bureau of Environmental Health Assessment
Emergency Response/Indoor Air Quality Program
August 2004

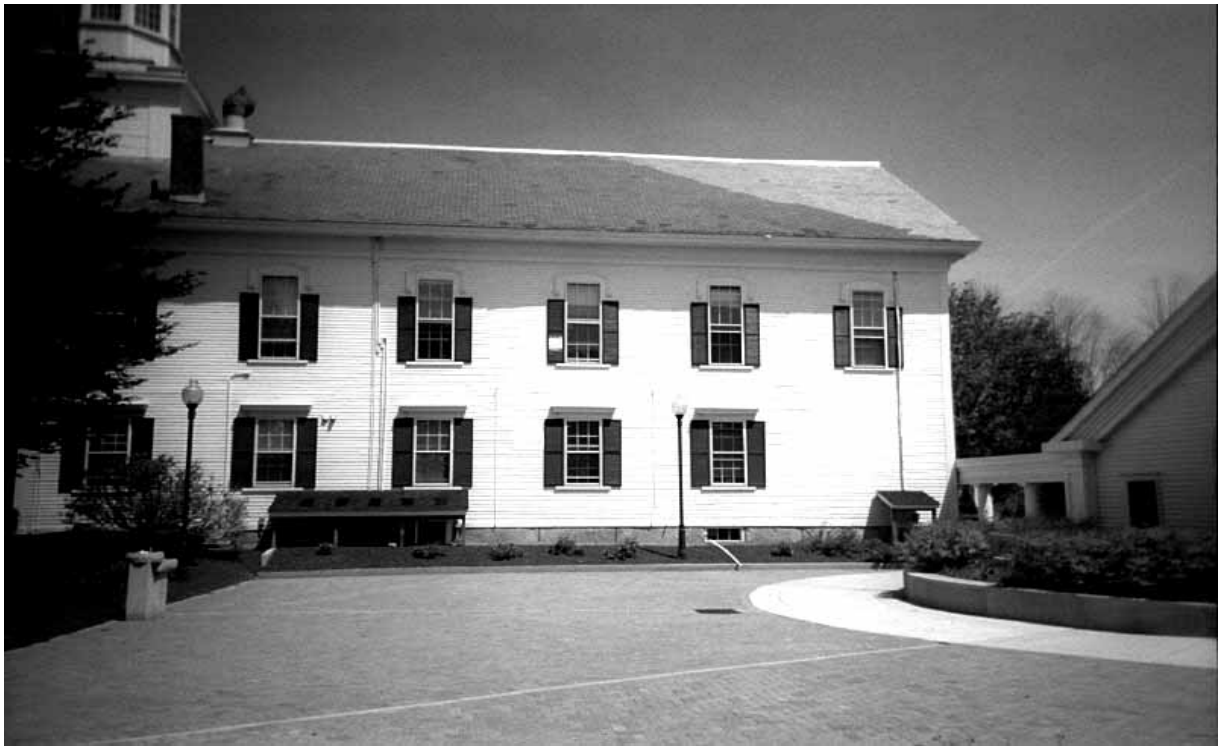
Picture 1

West Wall Windows of WTH

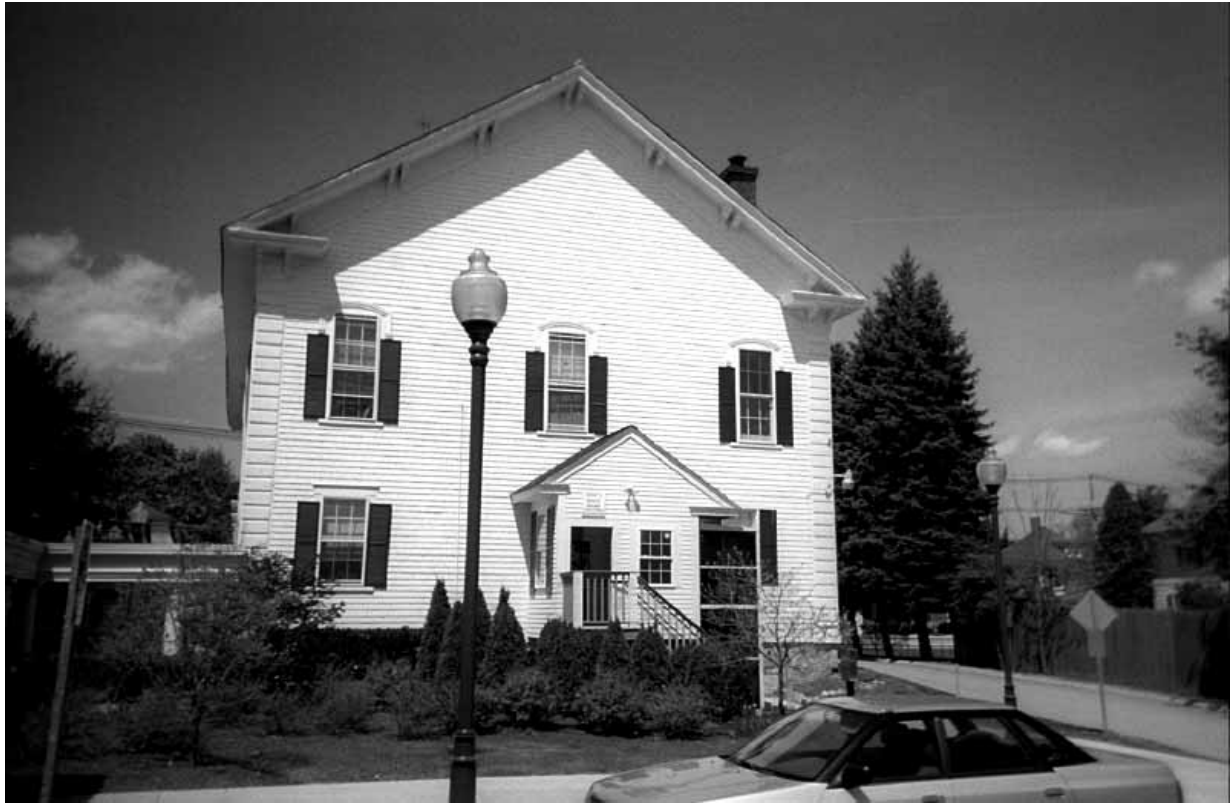
Picture 2

South Wall Windows of WTH

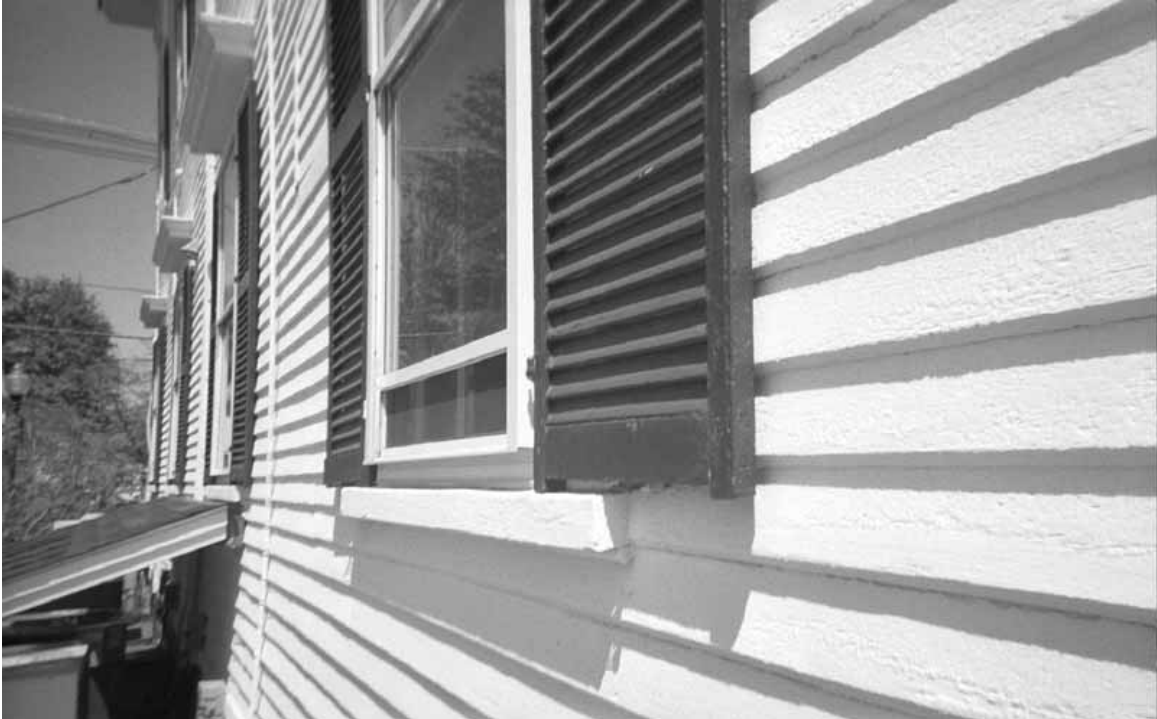
Picture 3

Based on these observations, the odors are likely related to the new window frames. The installation of these storm windows appears to have not been optimal. Visible light could be seen around frames, and gaps in window caulking were evident. In this condition, water exposure to the interior of the window frames is likely. The odors may be associated with exposure to driving rain. Moist weather tends to travel in a northeasterly track up the Atlantic Coast towards New England (Trewartha, G.T., 1943). Wet weather systems generally produce south/ southwesterly winds, which will expose the south and west facing walls to driving rain on a consistent basis, unlike the east and north walls where no odor was reported. Excessive exposure to moisture may have allowed water to penetrate into storm window frames, which are likely to contain a rubber-like material. Once water accumulates inside the window frame, it is exposed to the rubber-like material and may acquire the odor of the material. When the window frames are heated by sunlight, a vapor may be produced that creates this rubber-like odor.

Close Up Of West Wall Window with Storm Window

1. As a test, remove one window frame from an office with a closeable door (Collins office). If the odor is not present in the test office after a rainstorm followed by a sunny day, consideration should be given to the removal of storm windows on the south and west wall.

2. If the odor is still present in the test office after removal of the storm window, examine whether a rubber-like material was installed in the original window frame of the test office. Remove such material if present. If the odor is not present during sunny days in the test office, after the rubber-like material is removed, it is recommended that all rubber-like window materials on the south and west wall be removed/replaced.

3. If the odor is still present in the test office after removal of the storm window and rubber-like material, examination of the paint on window frames and exterior walls should be examined. Removal of the paint on widow frames and around seams of the window frame may be necessary.

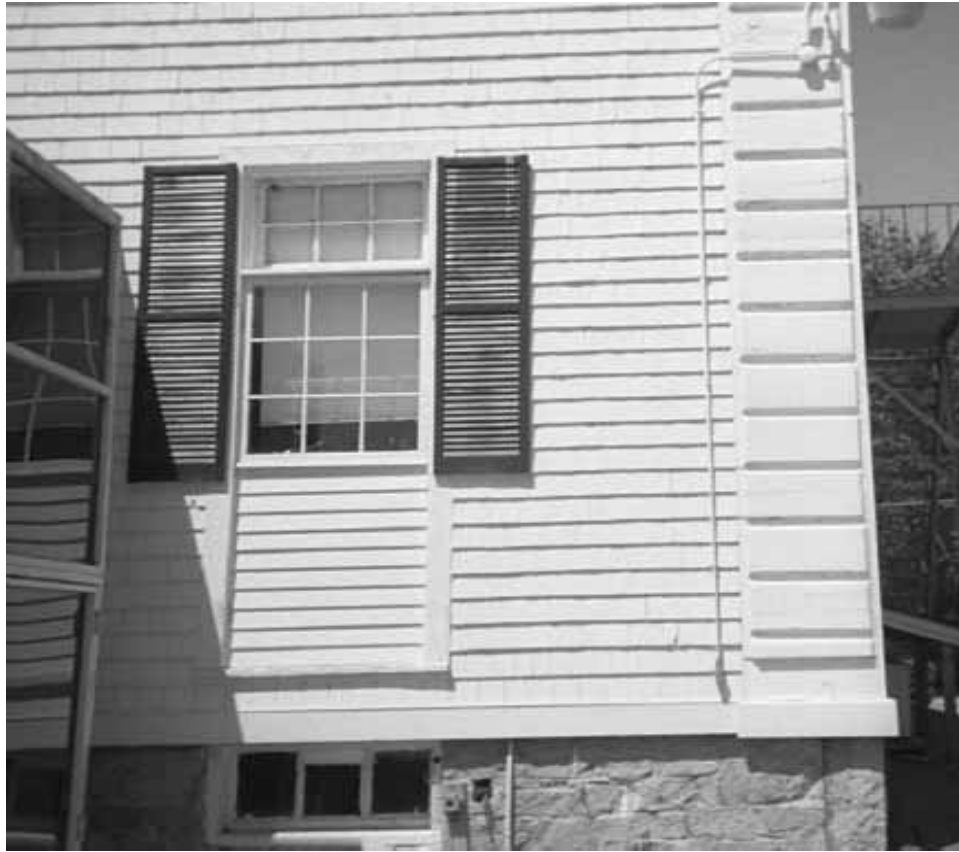
Picture 4

Of note was the lack of detectable odors in the financial director's office (the southeast corner office on the first floor) and the town accountant office (center work area on the first floor) at the same time odors were detected in second floor areas above these offices. All other south and west wall offices on the first and second floors had detectable odors simultaneous to when sunlight struck the windows (Pictures 1 through 3). These odors were particularly strong in offices with closeable doors (Collins and MacCaughey offices). BEHA staff examined the exterior of the building and noted that the two office areas without odors did not have new storm windows. The financial director's office south wall window does not have a storm window (Picture 4). The window for the town accountant office is an old, aluminum frame (the type of storm

Picture of First Floor Southeast Corner Office, Note the Lack of A Storm Window

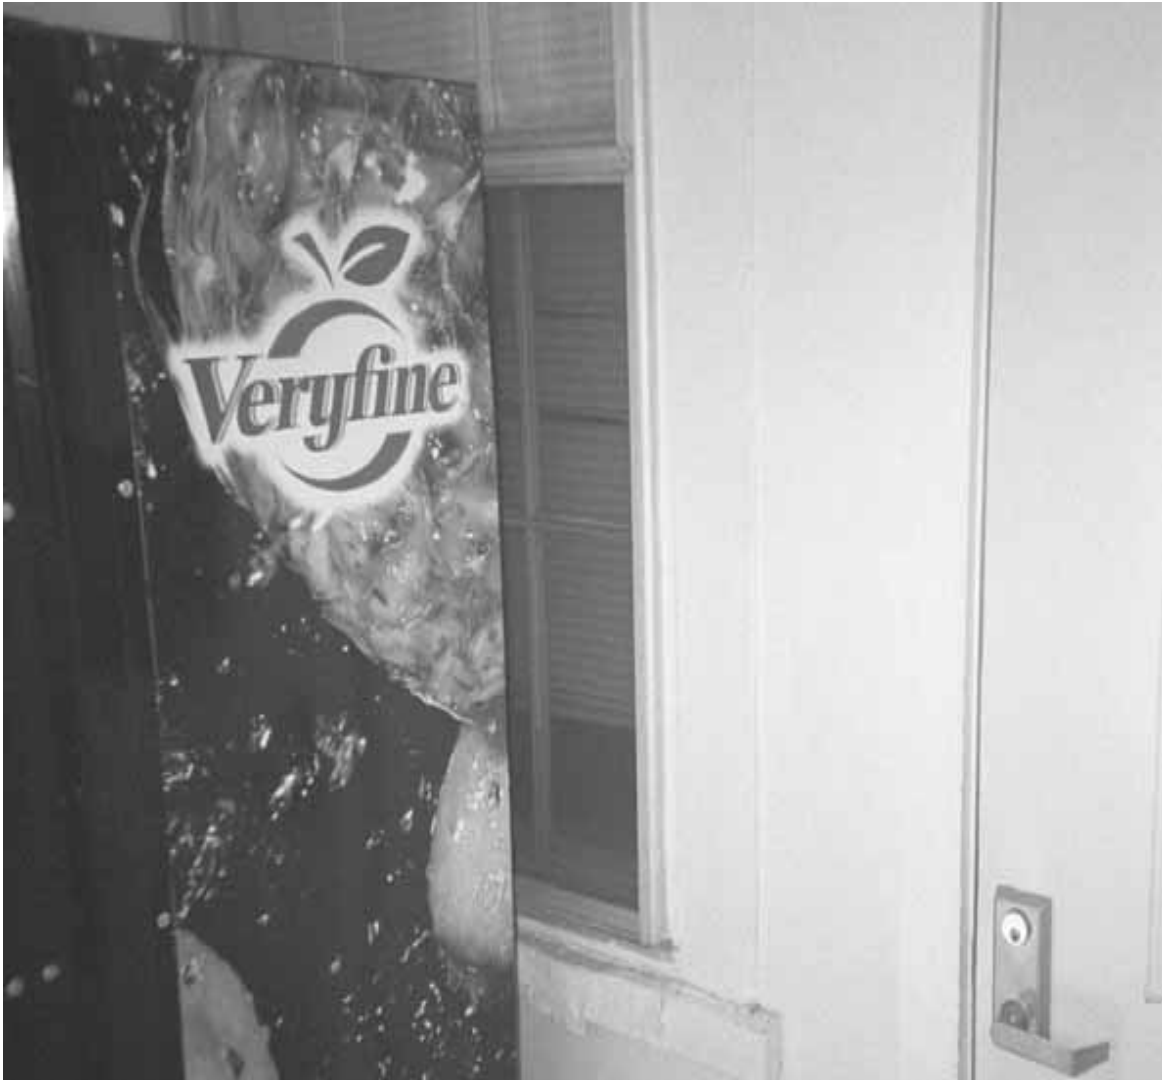
Picture 5

window that was replaced elsewhere) and is located within a foyer behind a vending machine (Pictures 5). All other offices areas along the south and west exterior walls are equipped with storm windows installed three years ago.

Window in Foyer Behind Vending Machine, Note Frame Is Unpainted Aluminum, Unlike Newly Installed Storm Windows.
